To minimise the movement of fertiliser contaminants into the environment from inloading operations of Summit Fertilizers, CSBP and Nutrien Ag Solutions at the Port of Esperance.

Clean-up Checklist for Fertiliser Inloading

CLEAN-UP CHECKLIST FOR FERTILISER INLOADING

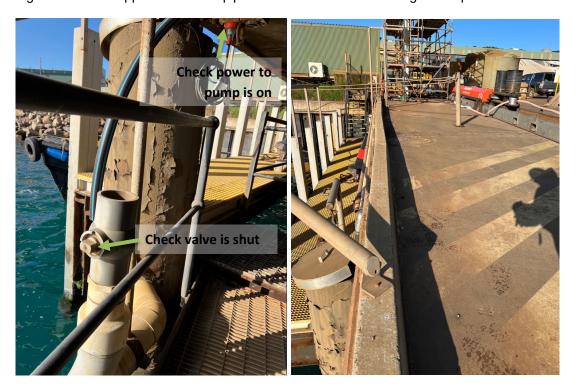
Figure 2 Berth outlet valve shown in closed position to divert water to tanks

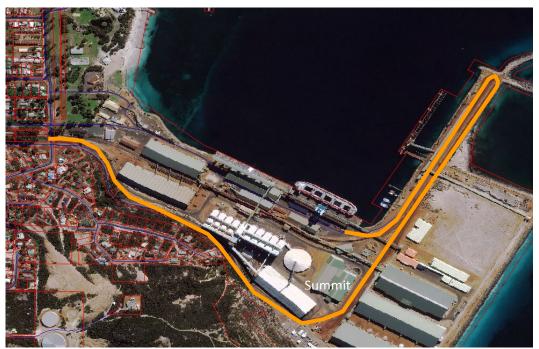
Figure 4. Route (orange line) to be swept by Stevedore commissioning a cleaning contractor on truck routes to and from Berth 2 using bobcat and sweeper attachment. Note: wet sweeping is only required on sealed roads at the end of the ship unloading. Unsealed areas require only clean-up of visible spillage. Additional sweeping maybe required at discretion of the Stevedore or the Terminal Supervisor.

All service lids in operating area are sealed watertight or covered with stormwater drain seals to prevent leaks					
Check condition of truck routes (Berth 2, and Hughes Road) for visible contamination shown in Figure 4					SPA-Esp and Receiver
During Operation Checks					
Task				Confirm Completion (initial)	Responsibility
Rainy weather? Sweep solids from Berth 2 and road access routes to minimise washing into stormwater system				Stevedore and receiver	
The following checks have been conducted to ensure no product is spilt from fertiliser trucks exiting the berth?					Stevedore/Transport company

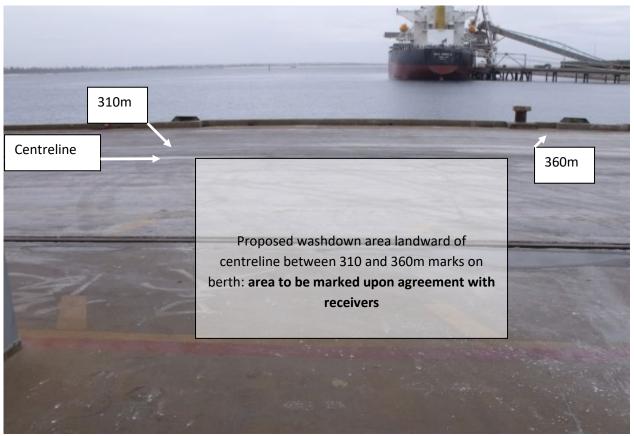
Figure 6. Alignment of hopper washdown between 310 to 360m mark on berth 2, landward of berth centreline. The area seaward of centreline should be kept clear to allow cleaning contractor to sweep up any spills from the containment used to capture hopper washings. Ensure all services lids are sealed in this area.

g. any other required actions are taken to prevent spillage from the trucks;					
h. if trucks cannot comply with above, are not authorised to leave site. Has all spillage on the berth and the entry/exit gates been cleaned for one hour by the stevedore using a bobcat					
with a sweeper attachment (area bounded by yellow line in Figure 5) during the shift change?					Stevedore
Post Vessel Unio	oading Checks				
	Tas	k		Confirm Completion (initial)	Responsibility
Stevedore or receiver's representative MUST BE PRESENT until clean-up is complete					Stevedore, Stevens Bulk and cleaning contractor (Environmental Services or Cleanaway or as appointed by product receiver)
Wet sweep of sealed roads from Berth 2 along Hughes Road to Smith Street junction (exit and entry routes shown in Figure 4) and clean-up visible spillage on unsealed areas					
Move fertiliser hoppers to designated cleaning areas seaward of Berth 2 centreline between 310-360m marks (Figures 6 and 7)
