# SOUTHERN PORTS – ESPERANCE

## ANNUAL ENVIRONMENT QUALITY MONITORING REPORT

1 October 2018 to 30 September 2019

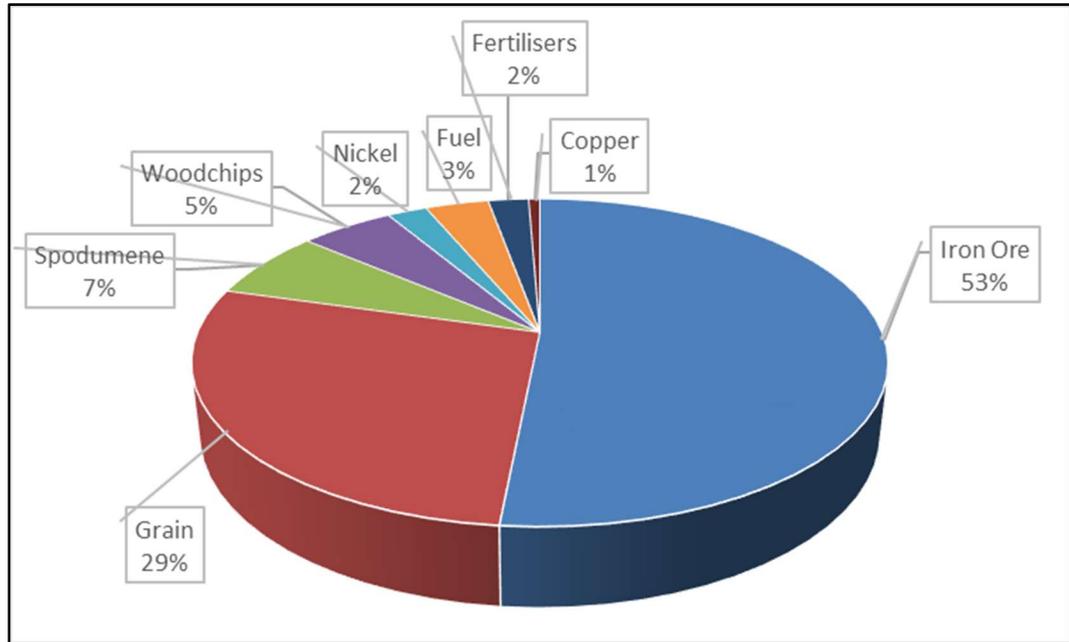
**Figure 1: 2018/19 Percentage of Southern Ports - Esperance Exports and Imports**

During the reporting period SPE had a total throughput of 8.5Mt of various commodities, a 28% decrease on the previous reporting period of 11.8Mt in 2017/18. A percentage breakdown of the various commodities (imports and exports) is shown in Figure 1. Of this total 5.6MT was of Category 58 products loaded in bulk (see Table 1).

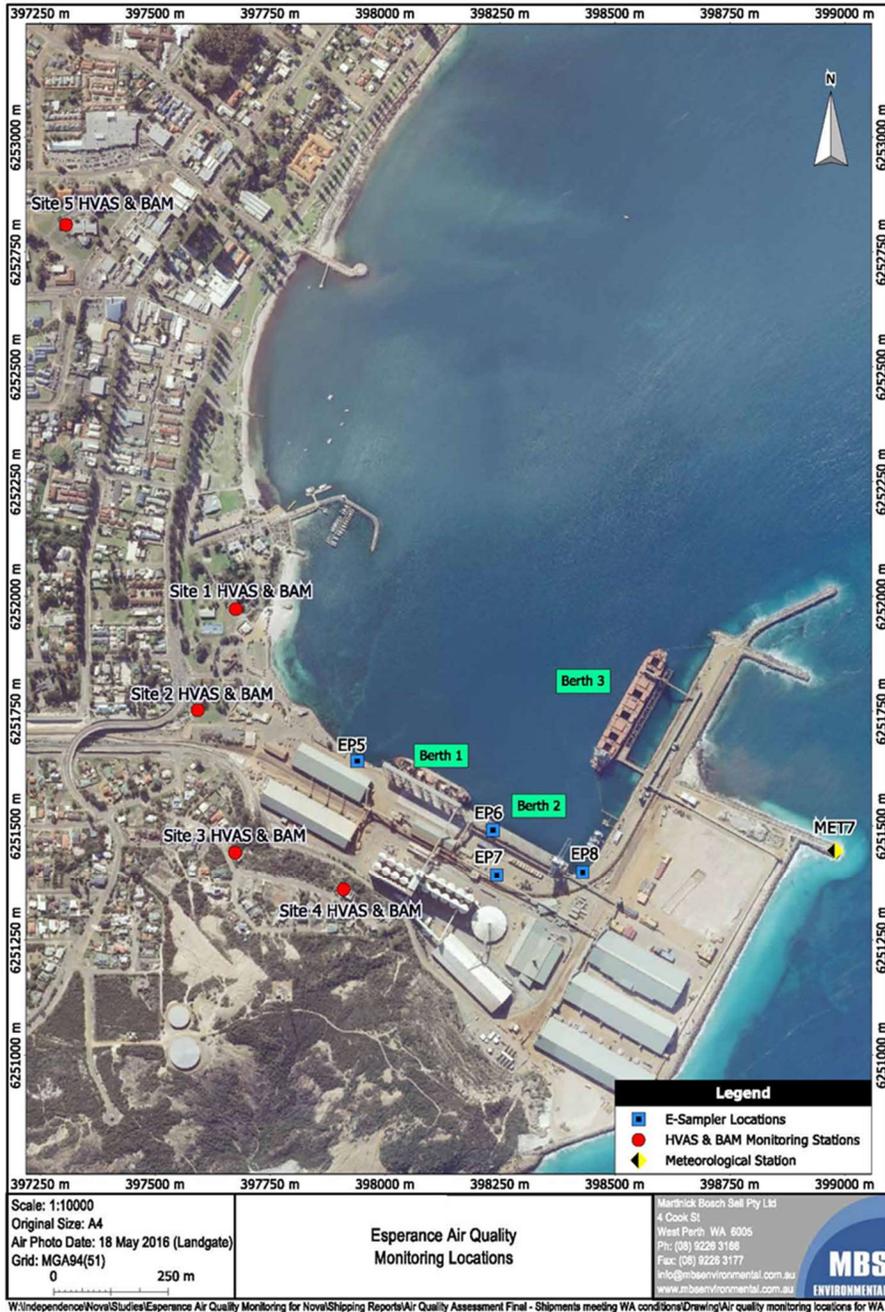
**Figure 2: Location of HVAS, BAM and E-sampler Air Quality Monitoring and Meteorological Stations at the Southern Ports - Esperance**

A meteorological station at MET7 that records rainfall, barometric pressure (not required by the licence), temperature (not required by the licence), wind speed and wind direction is installed on the Berth 3 finger groyne away from surrounding influences (see Figure 2). The meteorological station is compliant to Australian Standard 3580.14-2014.

As required by the Licence, ambient air quality monitoring is being undertaken at four locations (Sites 1 to 4) surrounding the SPE operations (Figure 2) and one location in the community approximately 1.6 km from the Port (Site 5). Siting of monitoring equipment is undertaken as far as practicable according to Australian Standard AS 3580.1.1-2016 Methods for sampling and analysis of ambient air – Guide to siting air monitoring equipment.

The devices (refer to Figure 2) installed at the five monitoring locations consist of:

Samples are collected from the network of air quality monitoring stations (refer to Figure 2) according to the following regime:

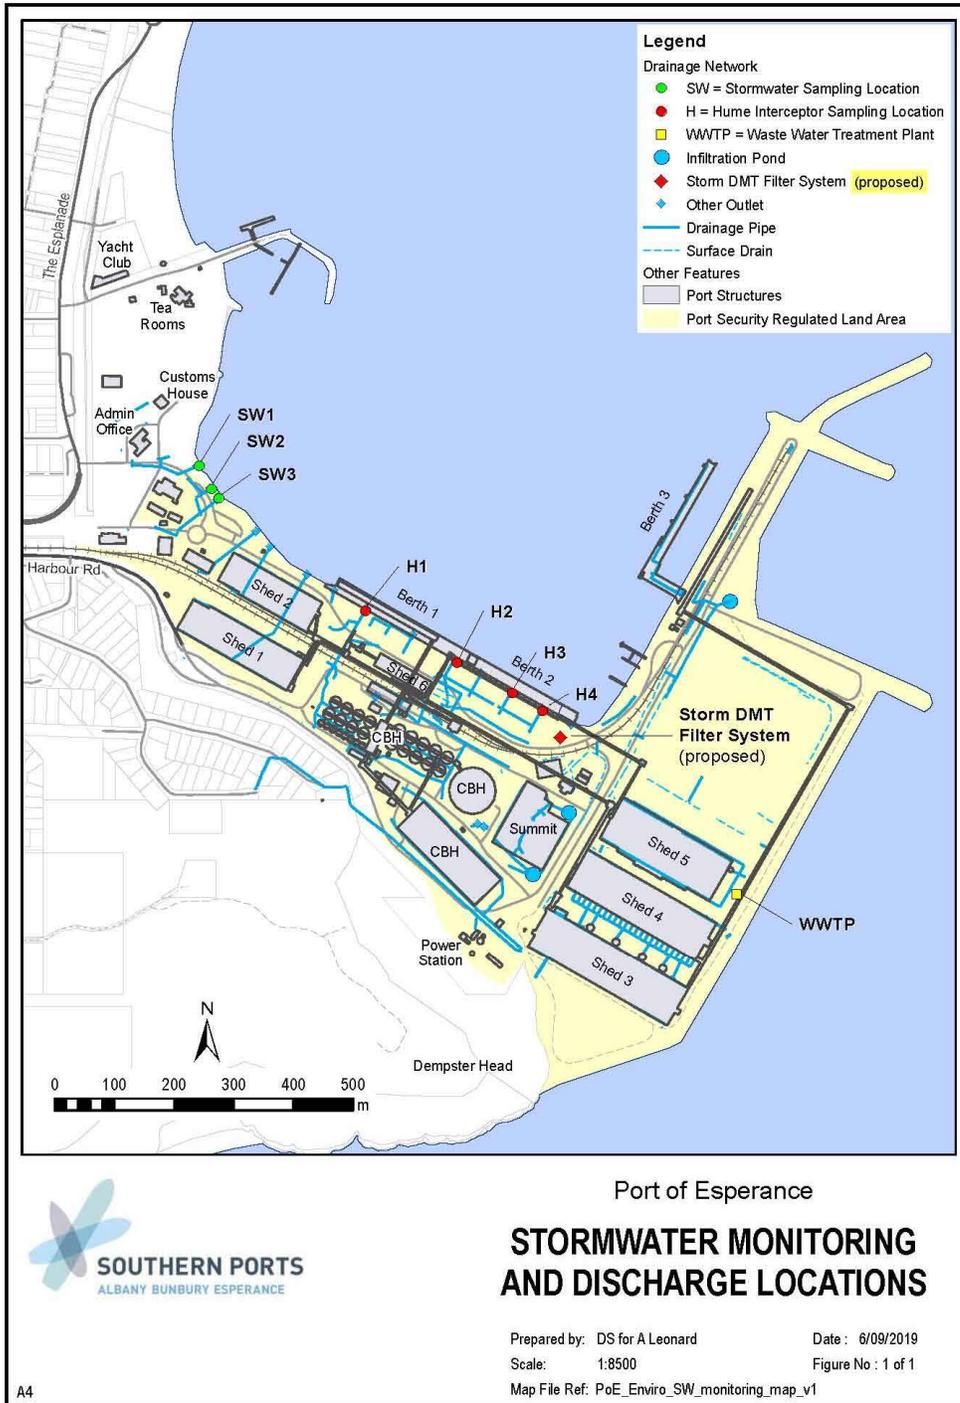
**Figure 3: Southern Ports - Esperance Stormwater Sampling Locations**

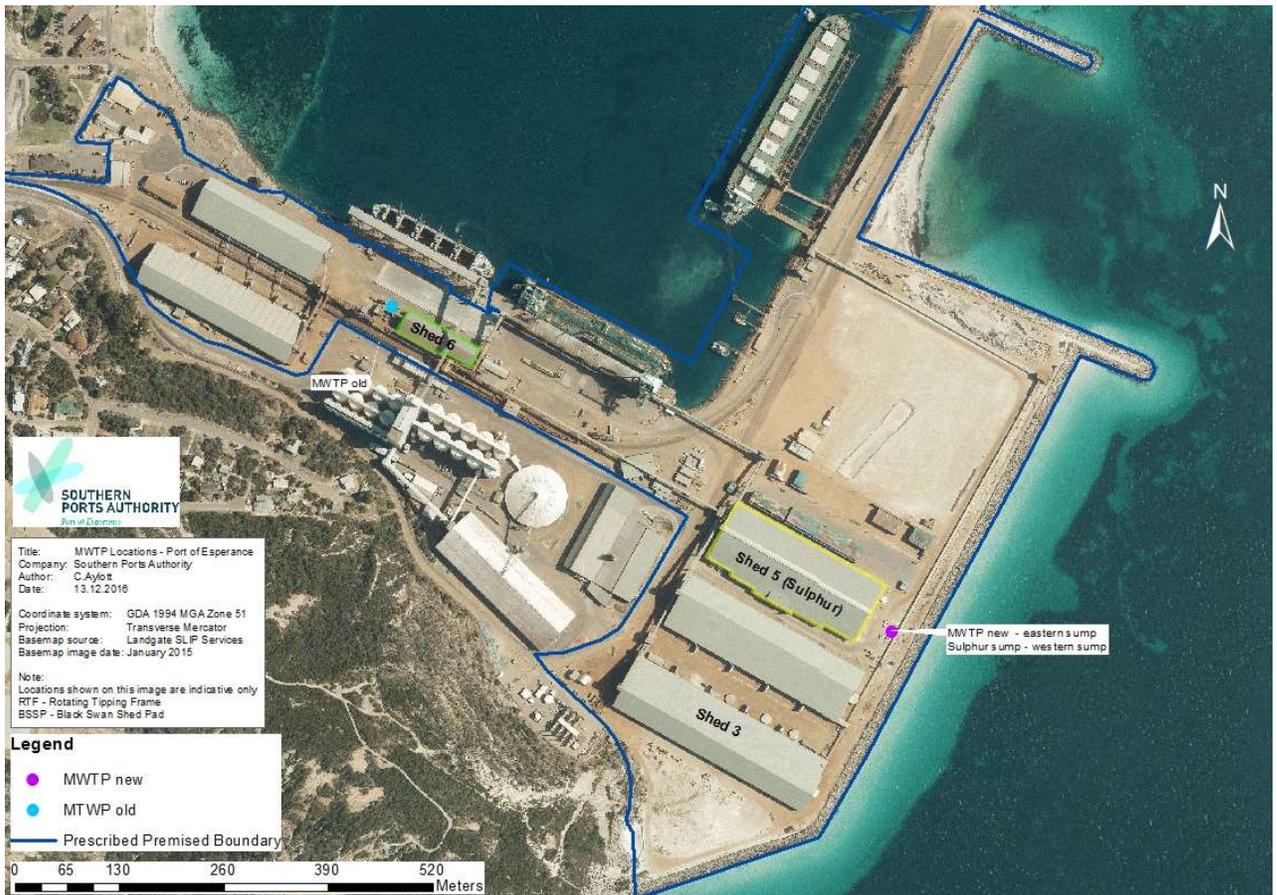
**Figure 4: Southern Ports - Esperance Location of Wastewater Treatment Plant**

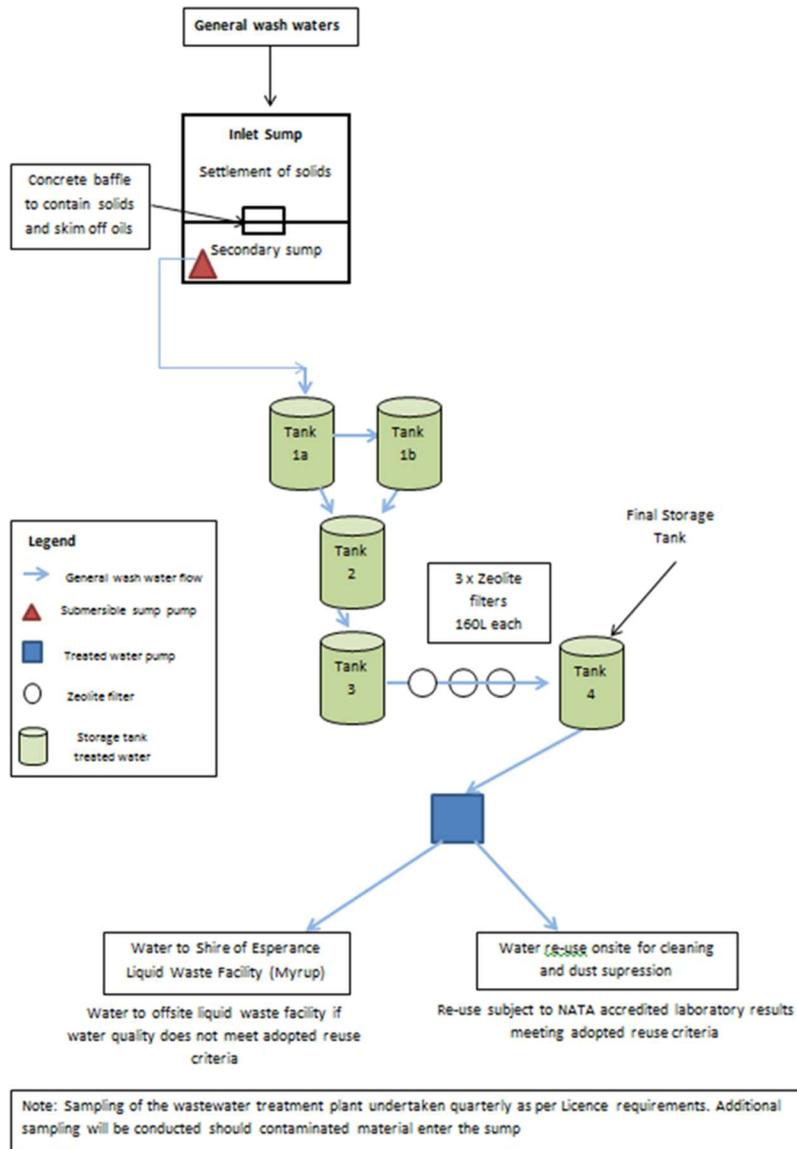
**Figure 5: Schematic of General Wastewater Treatment Process**

Between 100-200 KL of contaminated waters are transferred annually to the WWTP as general washwaters. A brief schematic of the WWTP process is provided in Figure 3. In summary the water is held in a sump to precipitate solids, filtered through a zeolite mineral filter and then stored in rainwater tanks. The treated water is then tested.

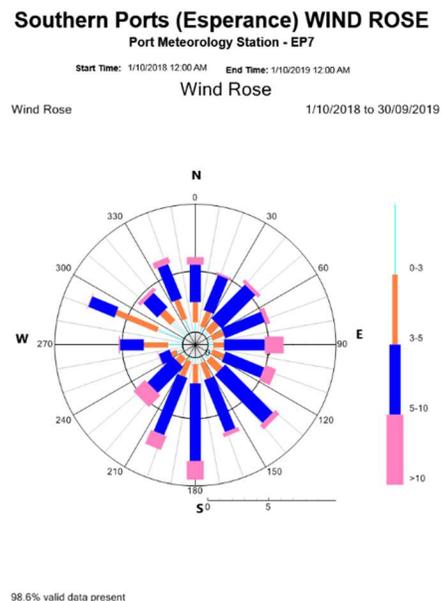
**Figure 6: Annual Wind Rose from 1st October 2018 to 30th September 2019**

The annual wind rose measured during the reporting period indicates variable wind directions throughout the year, with winds recorded at each compass point ranging from 5% to 9% (refer to Figure 6). The annual wind rose for the reporting period had similar distribution of wind direction for the 2017/18 reporting period with only minor differences between each quadrant. Wind data collected showed a bias towards more southerly wind directions including an arc from south easterly to south south-westerly winds. There was also a higher percentage of west north-westerly winds recorded. The overall wind conditions between the two years are comparable.

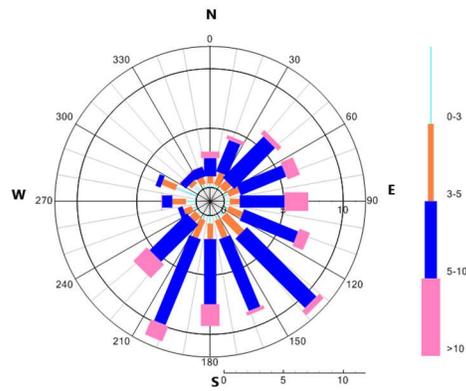
Wind Rose 1/10/2018 to 30/11/2018

96.2% valid data present

**Figure 7: Spring Wind Rose (1st October to 30th November 2018)**

The winds in October and November were in all directions and typical of spring conditions. The most predominant arc was from E to SW (Figure 7). Winds during spring were fairly strong and got above 10.0 m/s in some directions, but mostly in the southerly and easterly direction. The wind direction was similarly concentrated in the easterly and southerly directions but included less north-easterly directions in the same period as last year.

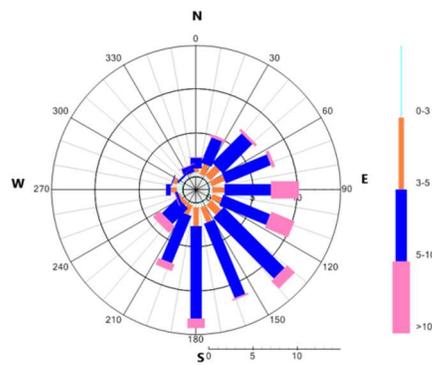
Wind Rose 1/12/2018 to 28/02/2019

99.8% valid data present

**Figure 8: Summer Wind Rose (30th November 2018 to 28th February 2019)**

In summer (December 2018 to February 2019), the majority of the winds were located in an arc between easterly and southerly winds with winds (>10%) blowing predominately (>10%) in the south easterly direction (see Figure 8) which is typical of summer winds in Esperance. Winds were very similar to the previous year.

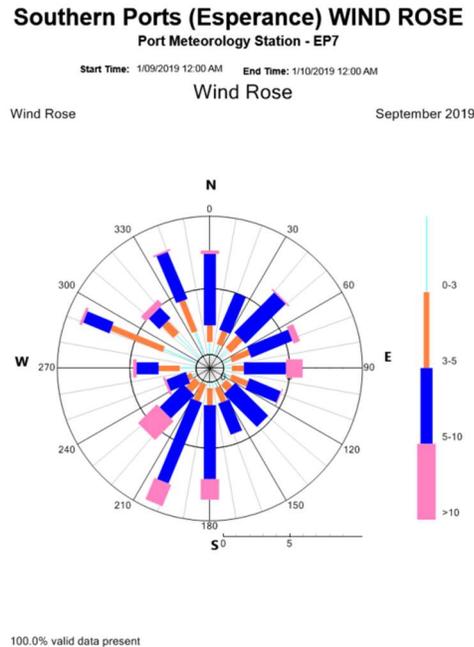
**Figure 11: September 2019 Wind Rose (1st to 30th September 2019)**

The winds in September 2019 month were very variable (see Figure 11) and in all directions, more like autumn winds. Northerly and southerly winds were more dominant. September 2019 was vastly different to the previous year when winds were more concentrated in the south-westerly directions.

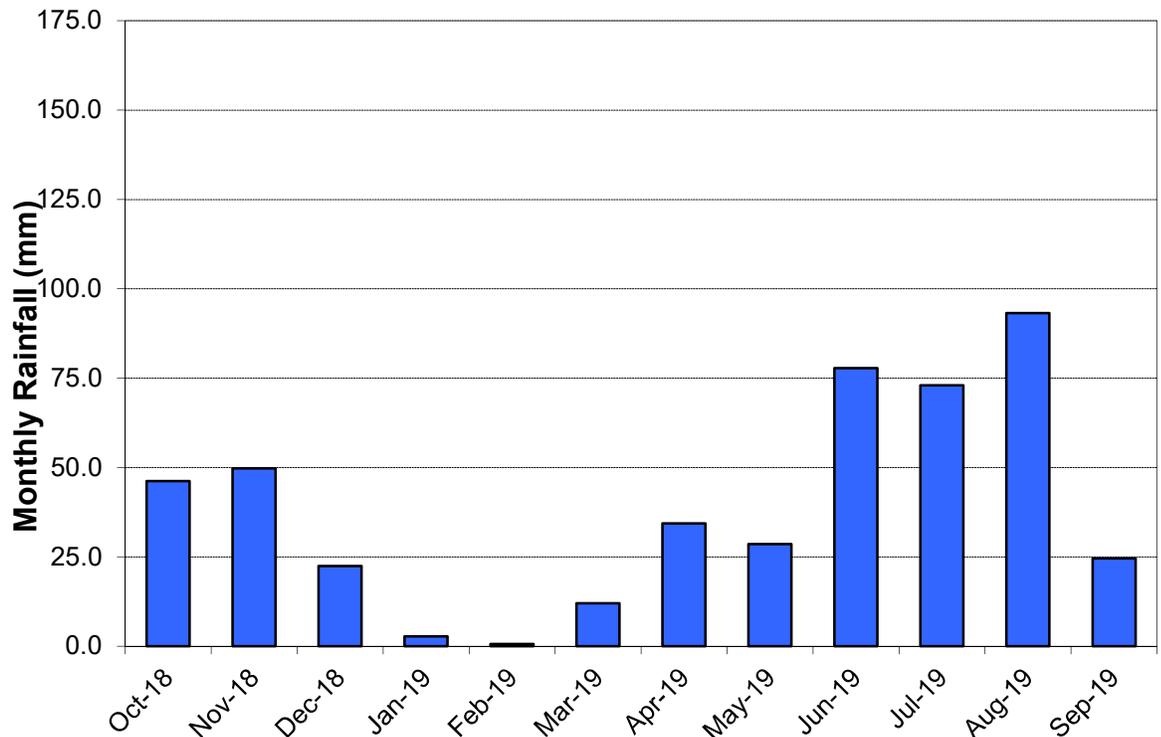
**Figure 12: Monthly Rainfall from October 2018 to September 2019**

The annual rainfall recorded at SPE's meteorology station for 2018/19 reporting period was a 465.4mm (see Figure 12). This rainfall was slightly

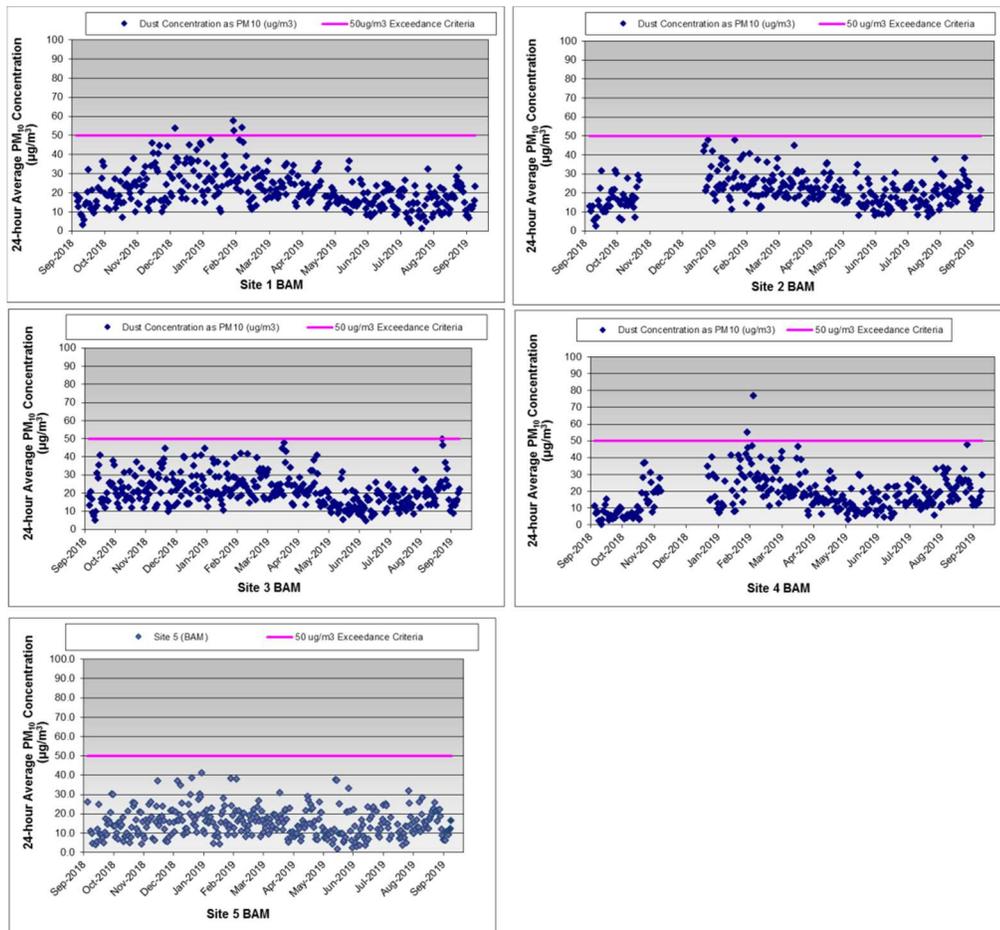
Figure 13: Daily PM<sub>10</sub> Concentrations (µg/m<sup>3</sup>) from October 2018 to September 2019

Average daily particulate matter of less than 50µm (PM<sub>10</sub>) is presented as a time series scatter plot in Figure 13. Validated average daily PM<sub>10</sub> concentrations are also available in Appendix 1. PM<sub>10</sub> dust concentrations were compared to the licence assessment criteria of 50µg/m<sup>3</sup> as a maximum 24-hour average concentration for PM<sub>10</sub> (NEPC, 2016 and Licence L5099/1974/14);

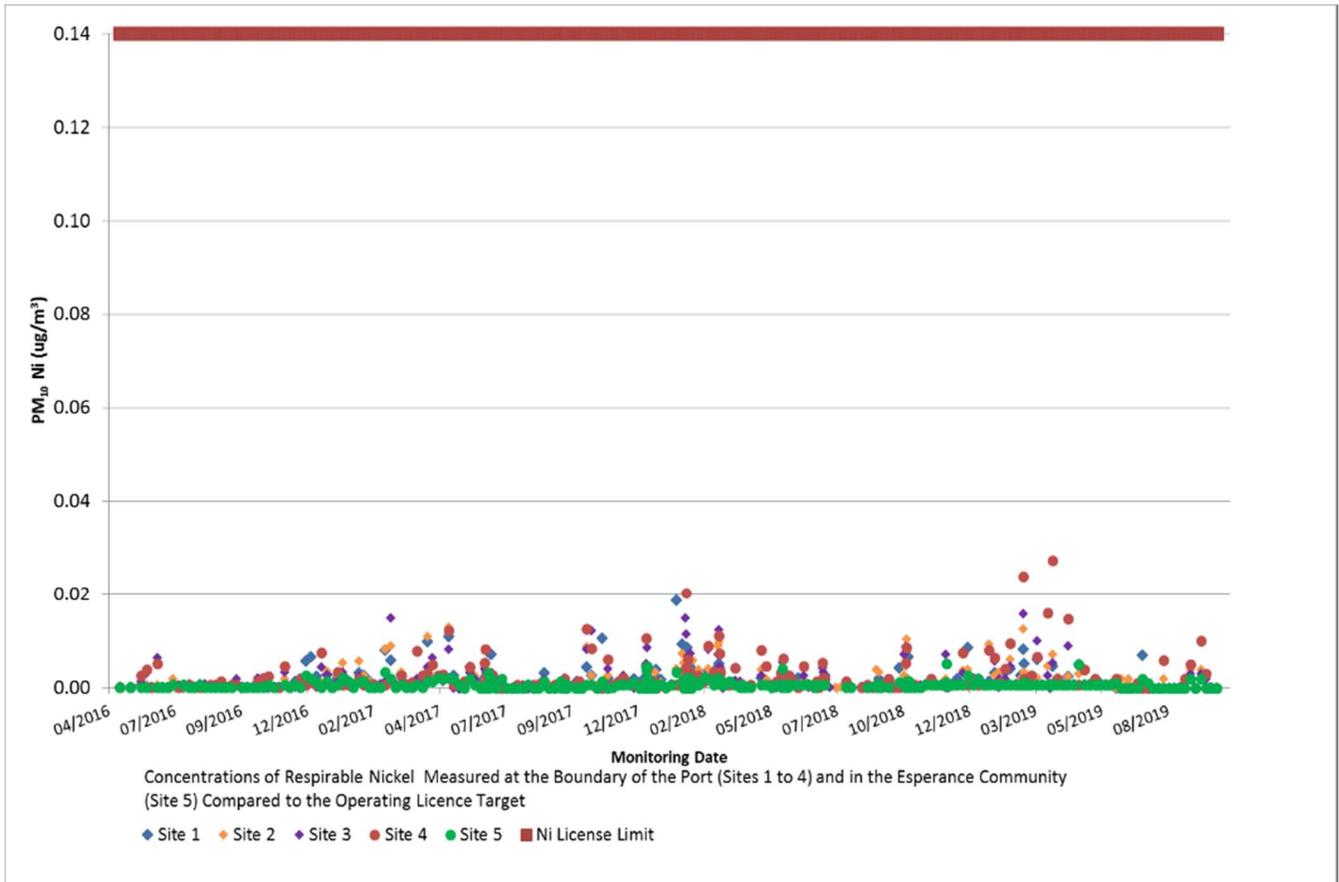
**Figure 14: Concentrations of Nickel as PM<sub>10</sub> (µg/m<sup>3</sup>) from HVAS monitors from May 2016 to September 2019**

Nickel concentrations of PM<sub>10</sub> throughout the reporting period were all over five-fold below Southern Port's daily licence limit of 0.14 µg Ni/m<sup>3</sup>. The highest nickel value for the reporting period was 0.0273 µg/m<sup>3</sup> at Site 4 between 25/03/2019 and 26/03/2019 (see Appendix 3). This maximum value was recorded in the 24 hours after the loading of a nickel shipment which had left at 25/03/2019 13:06. Only four other concentrations during the reporting period were above 0.01 µg/m<sup>3</sup> (see Figure 14). There was an increase in nickel concentrations in PM<sub>10</sub> during the summer months, the results show the loading controls and post shipment hygiene were effective in mitigating any nickel concentrations close to the licence criterion of 0.14 µg/m<sup>3</sup> during the nine shipments over the reporting period.

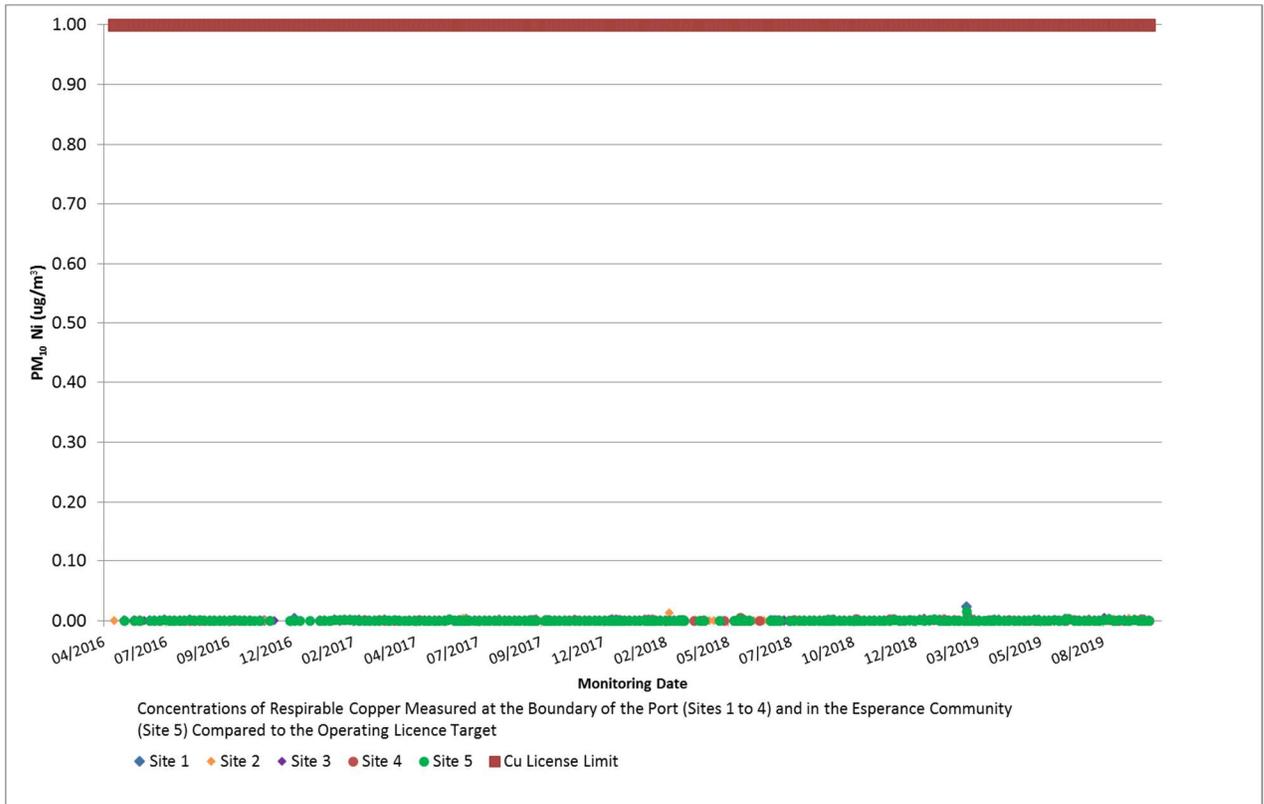
**Figure 15: Concentrations of Copper as PM<sub>10</sub> (µg/m<sup>3</sup>) from HVAS monitors from May 2016 to September 2019**

Copper concentrations of PM<sub>10</sub> throughout the reporting period were all below Southern Port’s daily Licence limit of 1.0µg/m<sup>3</sup>. The highest copper value for the reporting period was 0.004µg/m<sup>3</sup> at Sites 1, 2 and 3 on various dates (see Appendix 3). The 0.004µg/m<sup>3</sup> concentration was recorded at Sites 1 and 3 on 4/8/2019 to 5/8/2019 which didn’t coincide with copper shiploading. The 0.004µg/m<sup>3</sup> concentration was recorded four times at Site 2 on various dates including during copper shiploading. This value is however approximately 250 fold lower than the Licence criterion of 1.0µg/m<sup>3</sup> and have remained very low even during copper shiploading events (See Figure 15). There seems to be very little difference in copper concentrations even between seasons and in windy conditions. Overall, the results show the loading controls and post shipment hygiene were effective in mitigating any copper concentrations close to the Licence criterion of 1.0µg/m<sup>3</sup> during the nine shipments over the reporting period.

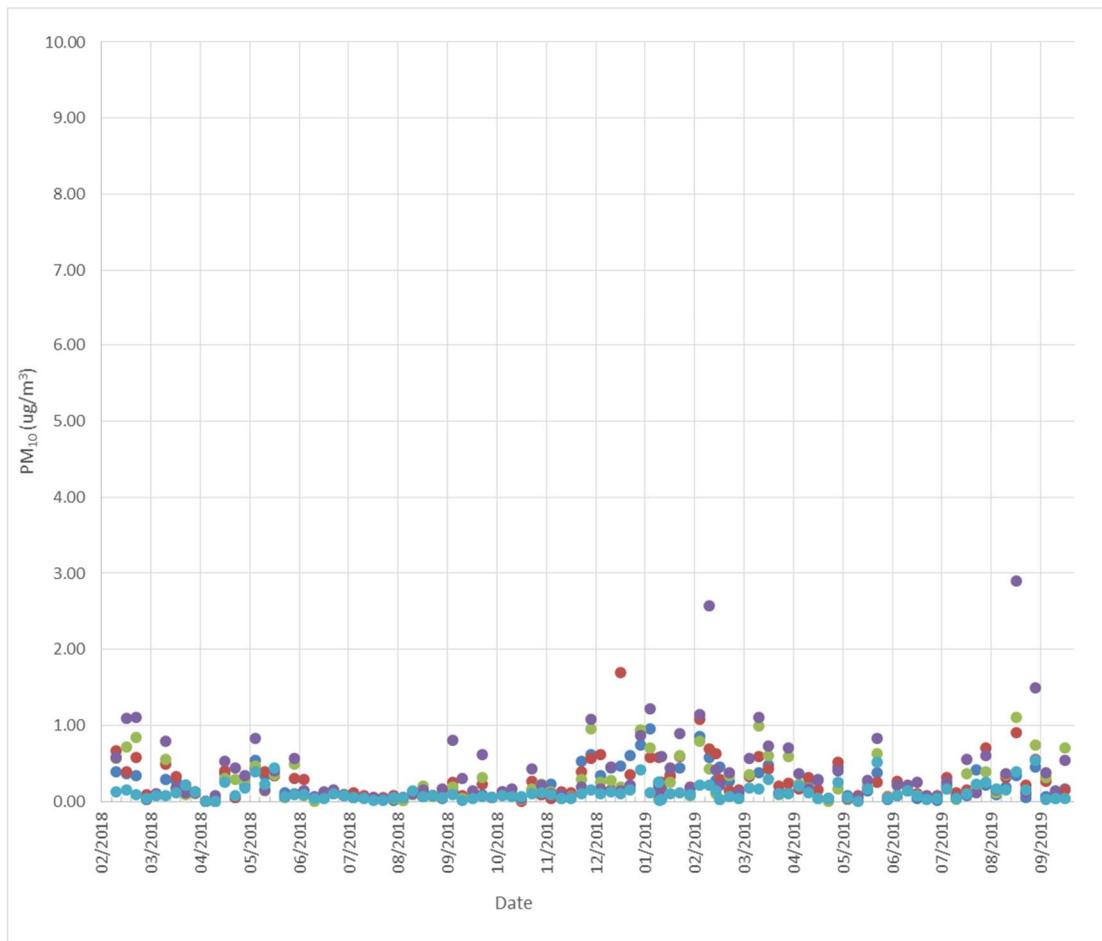
**Figure 16: Concentrations of Iron as PM<sub>10</sub> (µg/m<sup>3</sup>) from HVAS monitors from February 2018 to September 2019**

The majority of concentrations of iron in PM<sub>10</sub> over the period were 1.5µg/m<sup>3</sup> or below with only a handful of readings above this. The highest 24-hour average concentration of iron in PM<sub>10</sub> of 2.9µg/m<sup>3</sup> for the reporting period was measured at Site 4 between 28/08/19 12:00 to 29/08/19 12:00 (refer to Appendix 3 & Figure 16). This level of iron represented 10% of the PM<sub>10</sub> dust concentration which was 28µg/m<sup>3</sup> for the 24 hour period. This coincided with iron ore shiploading and a dust incident 24hrs later during this loading event. There is no Licence criteria for iron in PM<sub>10</sub> dust. The highest iron reading at Site 5, the community reference site was 0.44µg/m<sup>3</sup>. Which suggests a more general source of iron is present in the Esperance town.

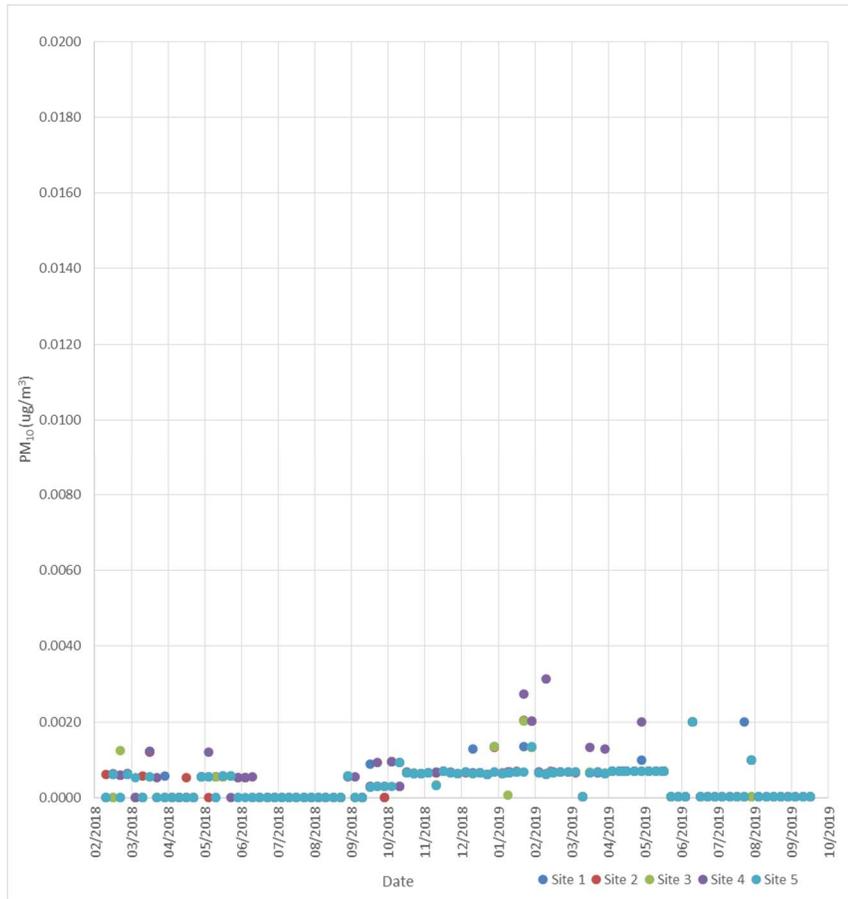
**Figure 17: Concentrations of Lithium as PM<sub>10</sub> (µg/m<sup>3</sup>) from HVAS monitors from February 2018 to September 2019**

During the reporting period, the highest lithium concentration in PM<sub>10</sub> was 0.0031µg/m<sup>3</sup> at site 4 on 23/2/19 to 24/2/19 when no spodumene was being loaded at either Berth 2 or Berth 3. This is a relatively low concentration of lithium given the limit of detection is approximately four fold lower at <0.0007µg/m<sup>3</sup>. There are no assessment criteria for lithium in air.

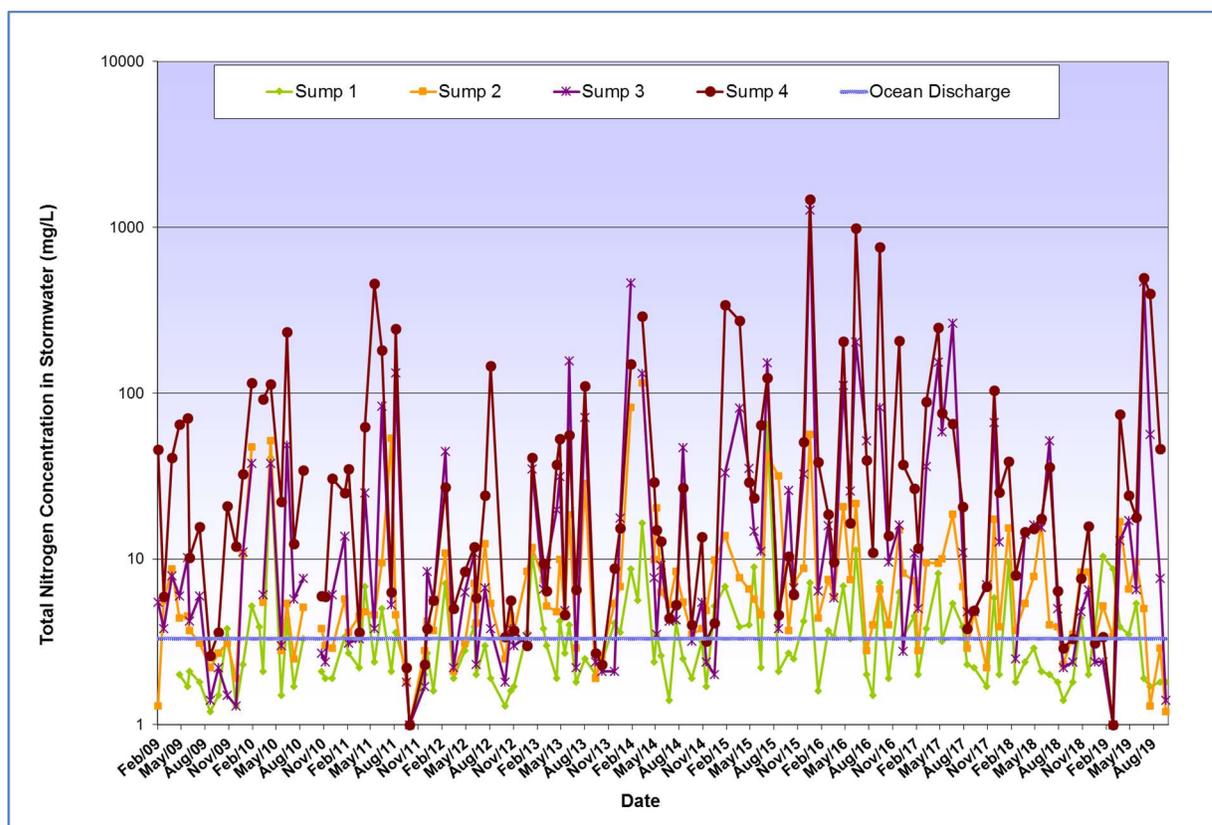
**Figure 18: Concentrations of Total Nitrogen in Stormwater (mg/L) from Hume Interceptors Draining Berths 1 and 2 from February 2009 to September 2019**
