# **Long Term Monitoring and Management Plan Port of Bunbury**

**College of Science, Health, Engineering & Education  
(Report No. MAFRL 21-03)  
Murdoch University  
September 2021**

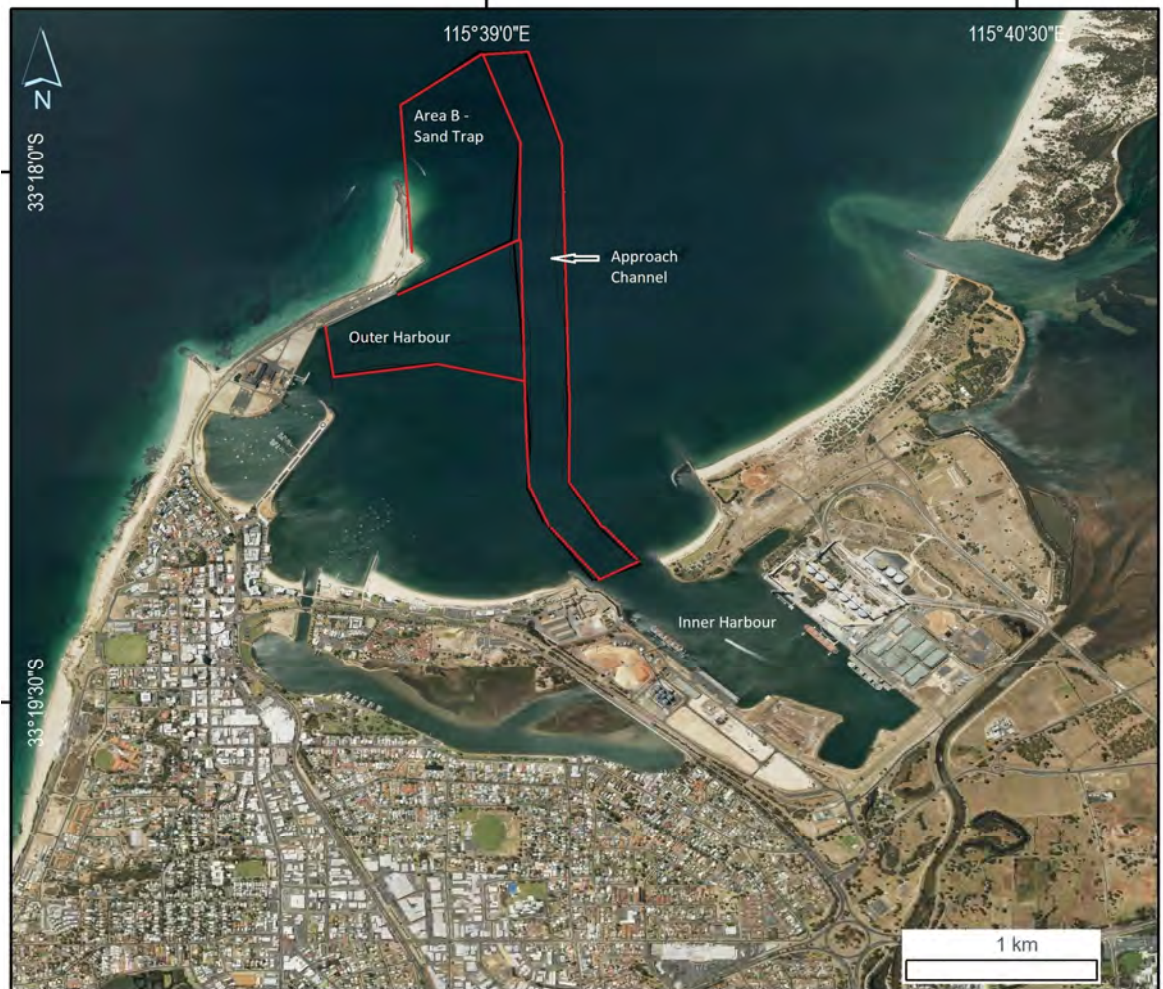
■ Figure 8 Three areas proposed for dredging
